APPENDIX E:
FEASIBLE CORRIDORS AND STAKEHOLDER'S MEETING #4
PHASE 2 GEOTECHNICAL PAPER STUDY

DMUT Conceptual Corridor 1

Washington County, Ohio

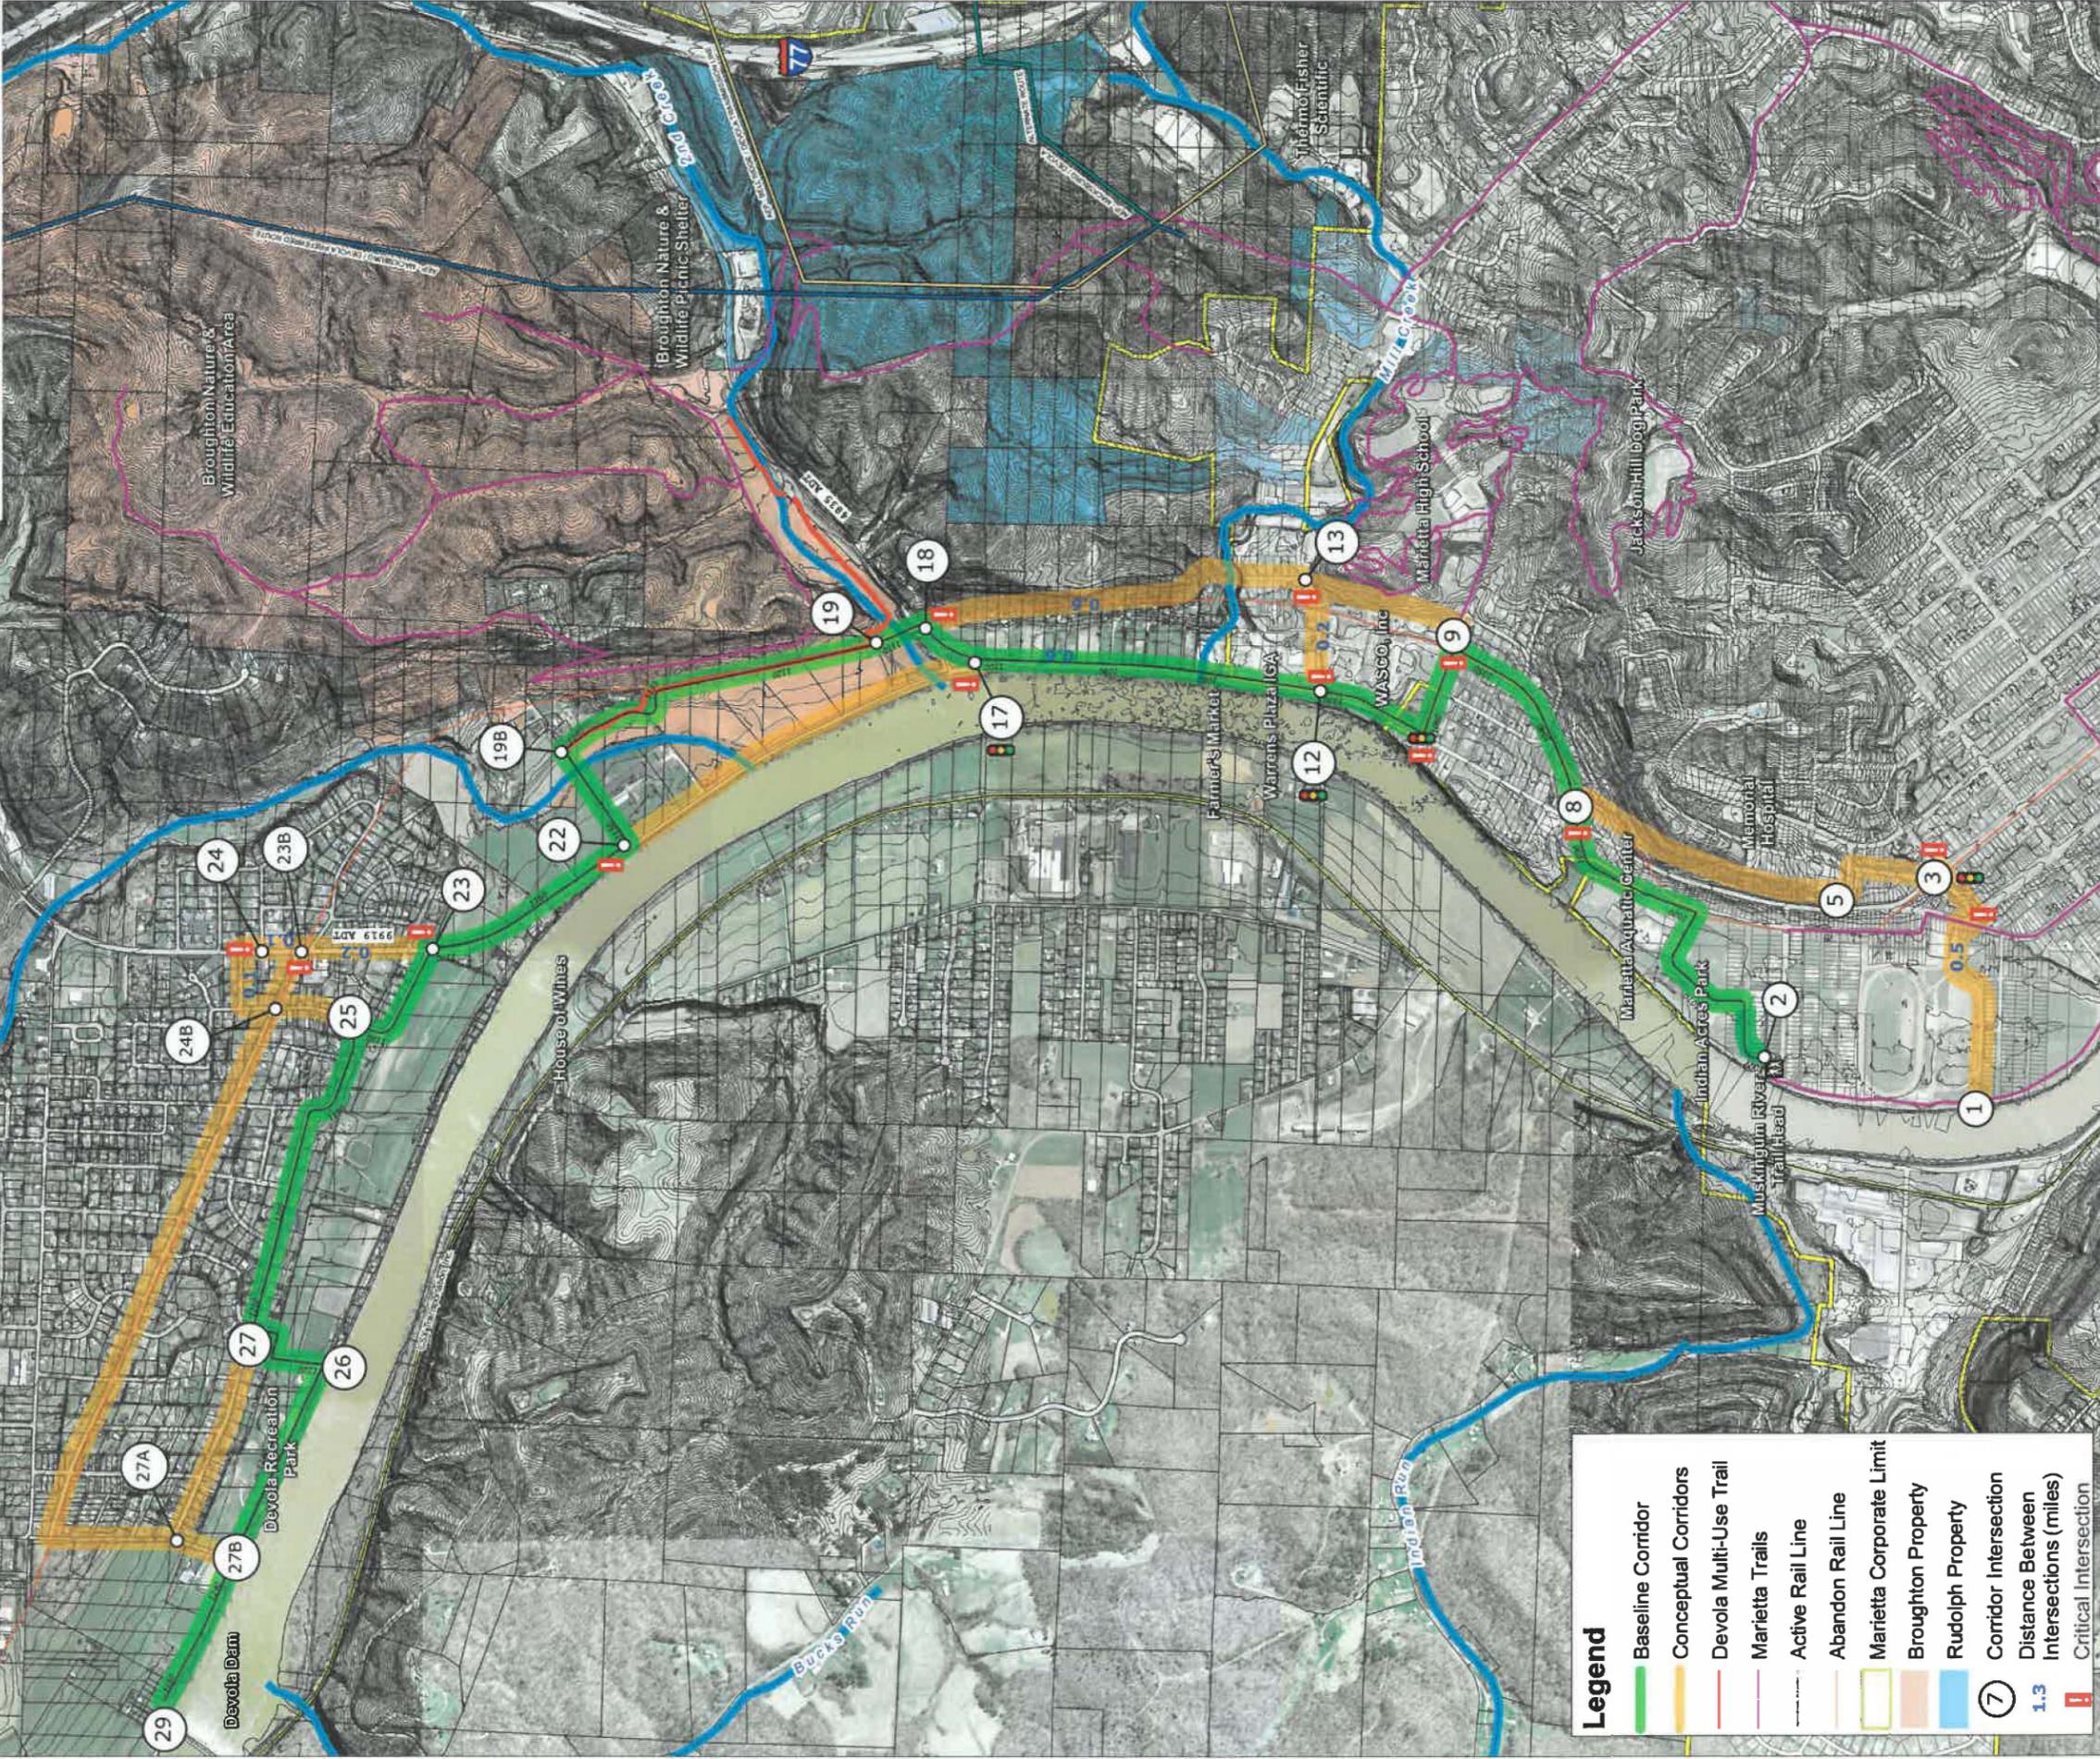
PLATE 1

Devola Multi-Use Trail Alternative Alignments

Plate 1 of Appendix A is a copy of the selected feasible alternative alignments provided to S&ME by Woolpert on June 22, 2018. Based on this drawing, S&ME compared these alternative corridors to available aerial photography, topographic mapping, and the geohazard maps included in S&ME's Phase 1 report. Using these available maps, S&ME identified several sections of the feasible alignments with potential geotechnical/geohazard concerns. On July 12, 2018, the undersigned Senior Engineer made a site visit to examine the project area and the sections of the feasible alignments with potential geotechnical concerns.

Using the corridor intersection numbers included on Woolpert's June 22, 2018, drawing (see Plate 1, Appendix A) to sub-divide the potential alignments into sections, S&ME presents the following additional discussions pertaining to geotechnical conditions which may be encountered and issues which should be considered during route selection and final design of smaller, more specific areas of the project.

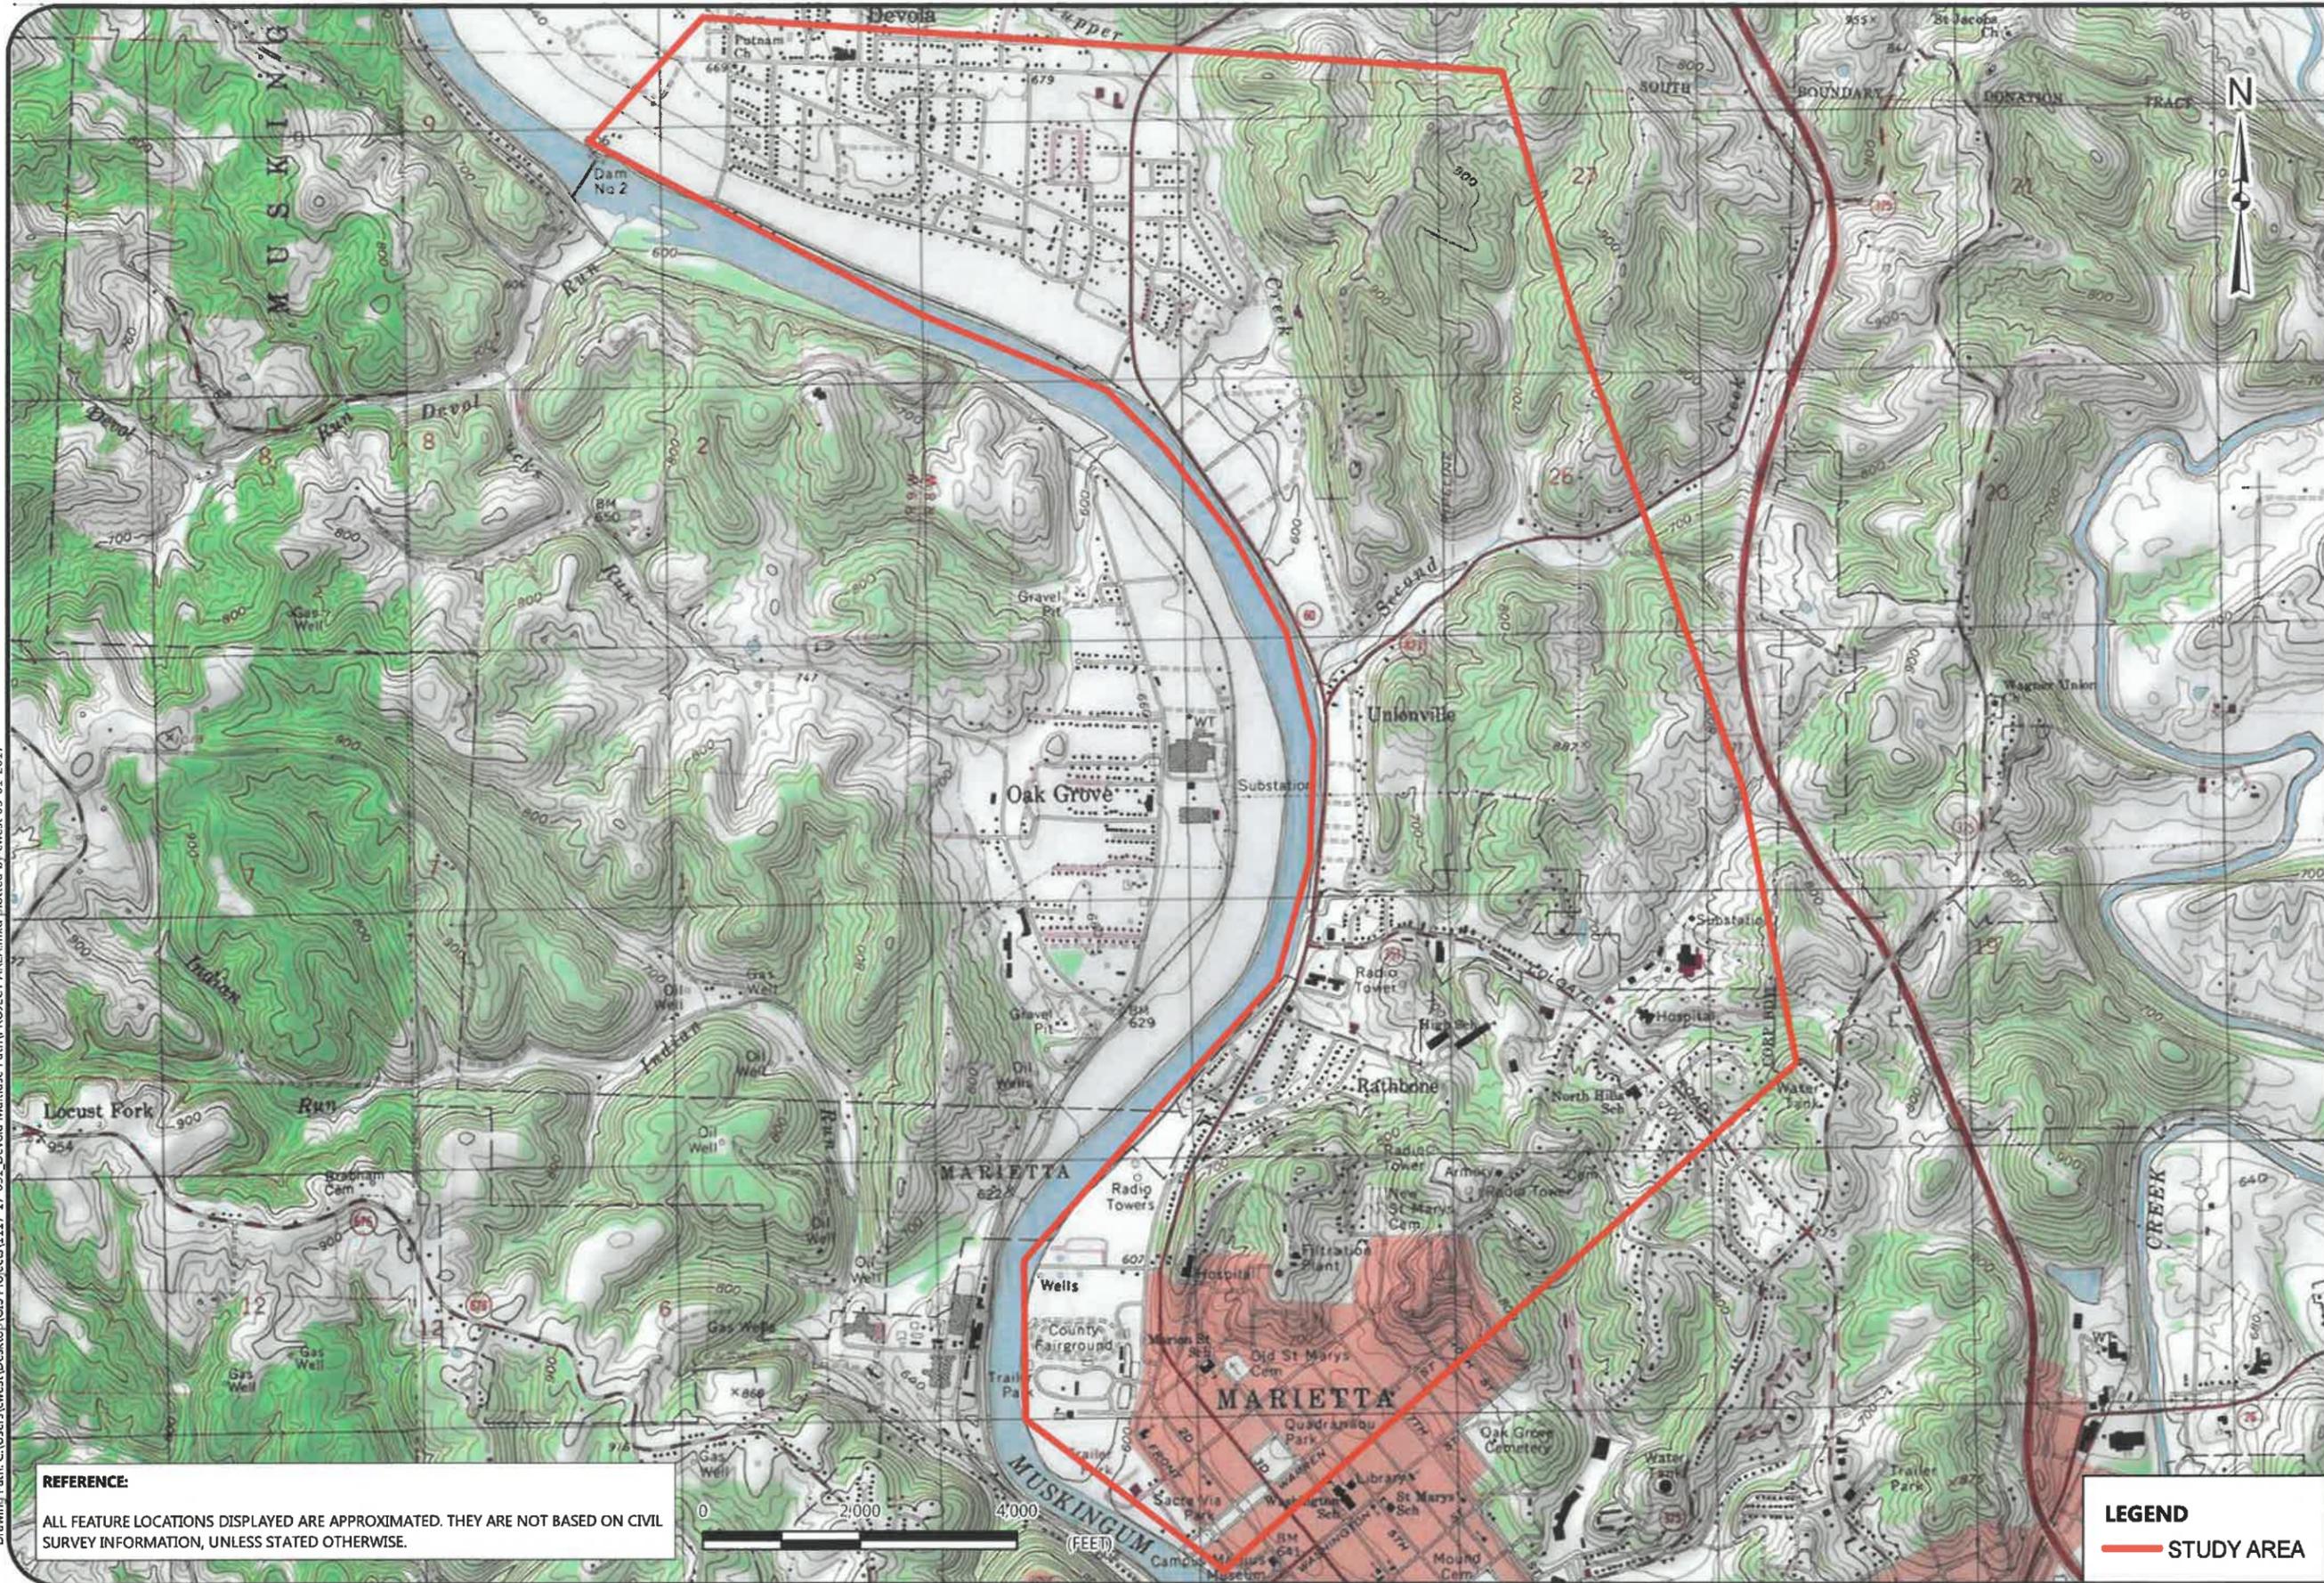
PROJECT AREA

DEVOLA MULTITUSE PATH
DEVOLA, WASHINGTON COUNTY, OHIO

Phase 1 of this project is to include a preliminary geotechnical assessment (desktop review) of the generalized project boundary area provided by Woolpert (see Plate 1 in the Appendix). Phase 2 will include a closer examination of roughly 3 Feasible Alternatives to be identified. We understand that depending on the feasible alternative(s) selected, future phases of the project may include geotechnical explorations, laboratory testing, analyses, and recommendations.

Using the generalized project boundary map provided by Woolpert on July 25, 2017, S&ME has reviewed readily available geologic and groundwater maps published by outside agencies such as ODNR, ODOT's Transportation Information Mapping System (TIMS) for the results of explorations from prior infrastructure projects, ODNR water well logs, and S&ME in-house resources, which include the findings from the previous geotechnical explorations/investigations we have performed in the vicinity of the project site. A summary of the geotechnical conditions which may be encountered by the proposed multi-use trail are herewith presented.

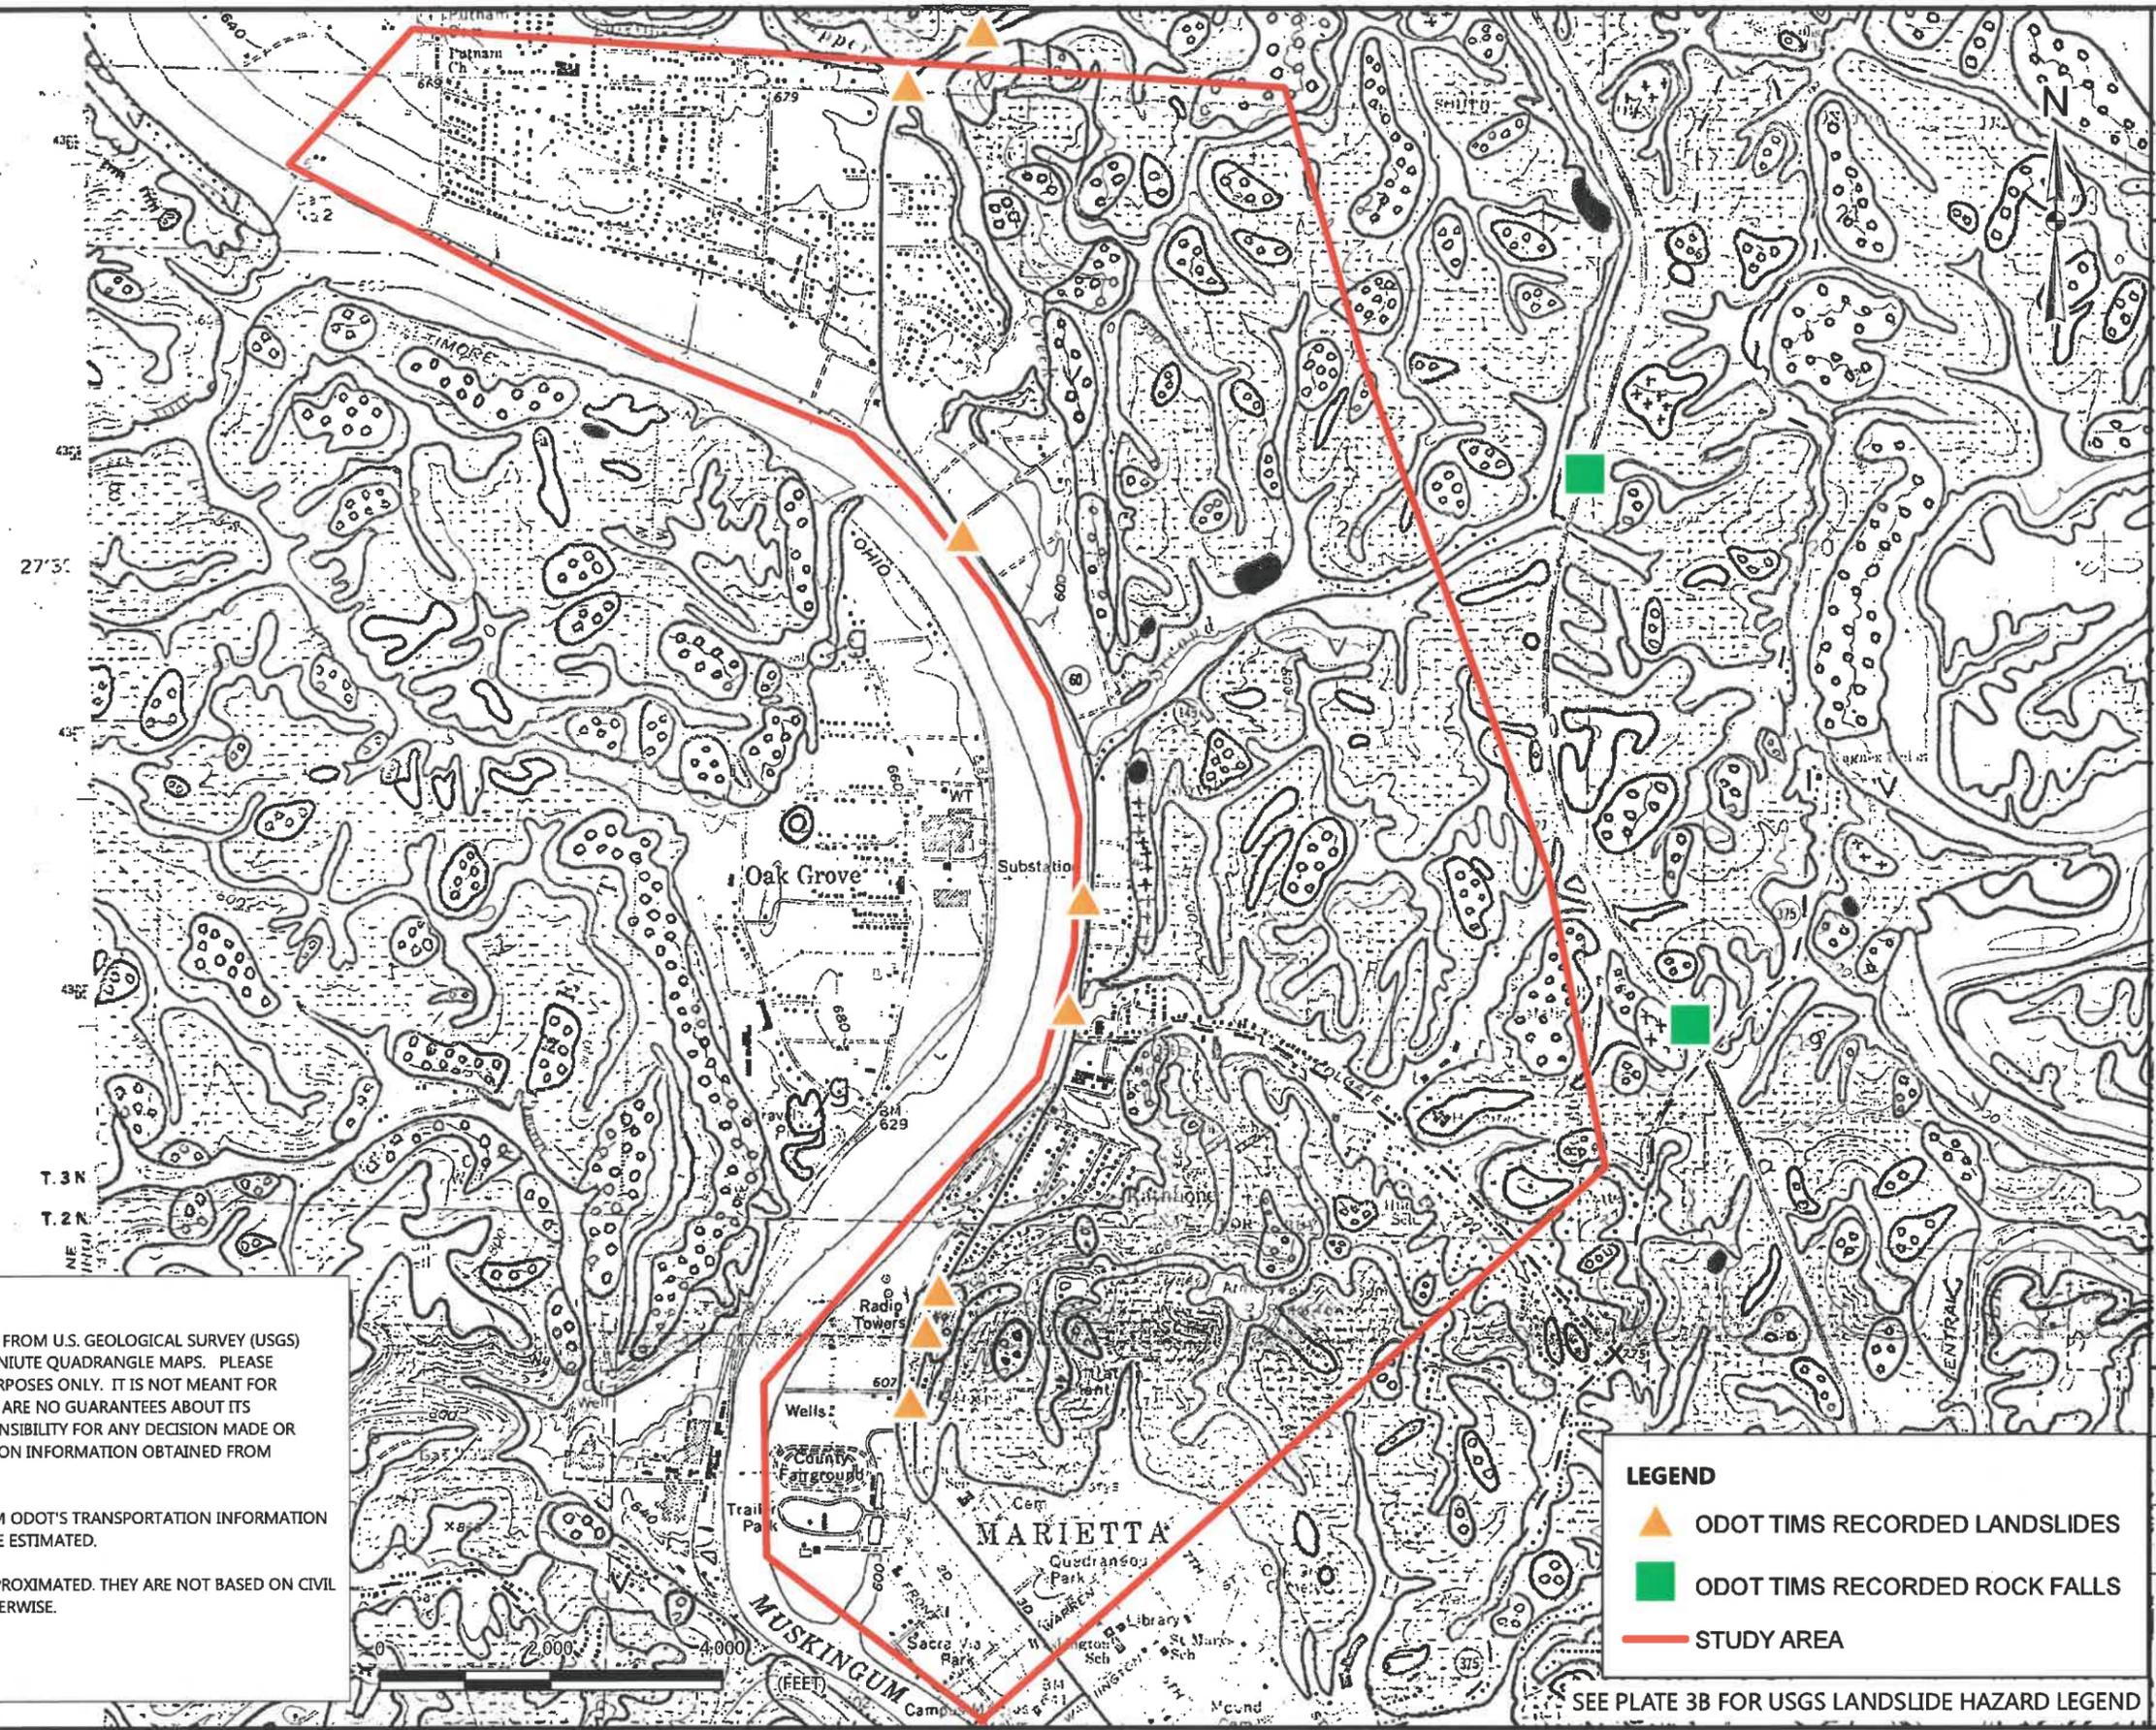
THE ABOVE LANDSLIDE DATA WAS OBTAINED FROM U.S. GEOLOGICAL SURVEY (USGS) "LANDSLIDE AND RELATED FEATURES" 7.5 MINUTE QUADRANGLE MAPS. PLEASE NOTE THIS DATA IS FOR INFORMATIONAL PURPOSES ONLY. IT IS NOT MEANT FOR DESIGN, LEGAL, OR ANY OTHER USES. THERE ARE NO GUARANTEES ABOUT ITS ACCURACY. S&ME, INC. ASSUMES NO RESPONSIBILITY FOR ANY DECISION MADE OR ANY ACTIONS TAKEN BY THE USER BASED UPON INFORMATION OBTAINED FROM THE ABOVE DATA.
